Army Lodging Wellness Recommendation

Final Submittal - Presidio of Monterey

February 27, 2004

Presidio of Monterey

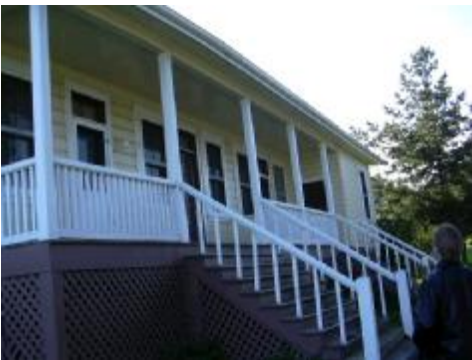
Building 354 A

354 A is one unit of a duplex constructed in 1906. This is a historical structure located in the residential district of the installation. The two bedroom apartment is in poor condition, does not meet Lodging standards and cannot be reconfigured without significant reconstruction. To renovate 354 A to the new standards and configuration will exceed 50% of the replacement cost.

Our recommendation is to remove unit 354 A from the Lodging inventory, allowing the installation to determine an alternate use for this unit. This unit will be removed from the Presidio of Monterey Wellness Solution and Lodging Master Plan.

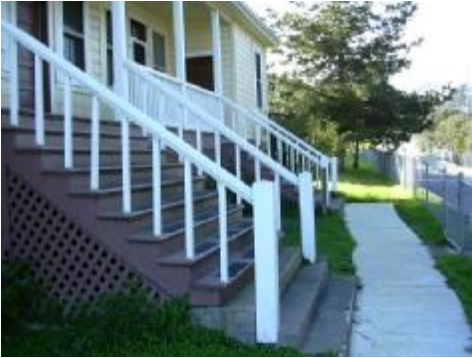
Building 354 B

354 B is one unit of a duplex constructed in 1906. This is a historical structure located in the residential district of the installation. The two bedroom apartments is in poor condition, does not meet Lodging standards and cannot be reconfigured without significant reconstruction. To renovate 354 B to the new standards and configuration will exceed 50% of the replacement cost.

Our recommendation is to remove unit 354 B from the Lodging inventory, allowing the installation to determine an alternate use for this unit. This unit will be removed from the Presidio of Monterey Wellness Solution and Lodging Master Plan.

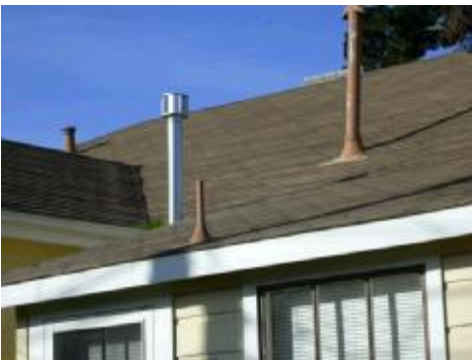
Building 356 A

356 A is one unit of a duplex constructed in 1906. This is a historical structure located in the residential district of the installation. The two bedroom apartment is in poor condition, does not meet Lodging standards and cannot be reconfigured without significant reconstruction. To renovate 356 A to the new standards and configuration will exceed 50% of the replacement cost.

Our recommendation is to remove unit 356 A from the Lodging inventory, allowing the installation to determine an alternate use for this unit. This unit will be removed from the Presidio of Monterey Wellness Solution and Lodging Master Plan.

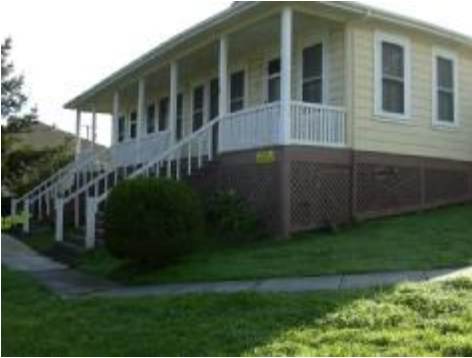
Building 356 B

356 B is one unit of a duplex constructed in 1906. This is a historical structure located in the residential district of the installation. The two bedroom apartment is in poor condition, does not meet Lodging standards and cannot be reconfigured without significant reconstruction. To renovate building 356 B to the new standards and configuration will exceed 50% of the replacement cost.

Our recommendation is to remove unit 356 B from the Lodging inventory, allowing the installation to determine an alternate use for this unit. This unit will be removed from the Presidio of Monterey Wellness Solution and Lodging Master Plan.

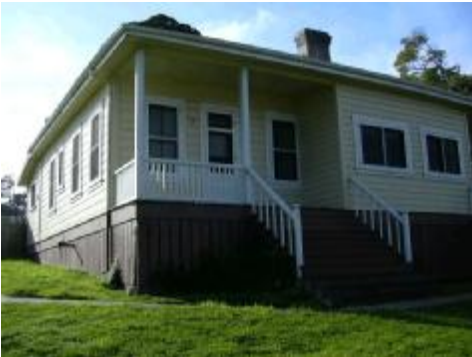
Building 358 A

358 A is one unit of a duplex constructed in 1906. This is a historical structure located in the residential district of the installation. The two bedroom apartment is in poor condition, does not meet Lodging standards and cannot be reconfigured without significant reconstruction. To renovate 358 A to the new standards and configuration will exceed 50% of the replacement cost.

Our recommendation is to remove unit 358 A from the Lodging inventory, allowing the installation to determine an alternate use for this unit. This unit will be removed from the Presidio of Monterey Wellness Solution and Lodging Master Plan.

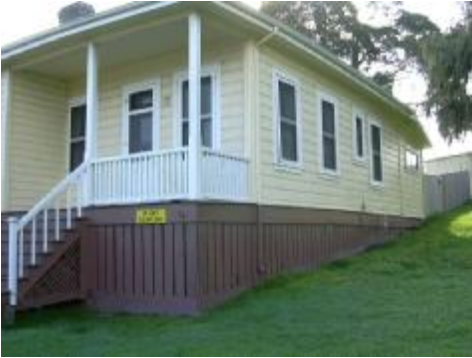
Building 358 B

358 B is one unit of a duplex constructed in 1906. This is a historical structure located in the residential district of the installation. The two bedroom apartment is in poor condition, does not meet Lodging standards and cannot be reconfigured without significant reconstruction. To renovate 358 B to the new standards and configuration will exceed 50% of the replacement cost.

Our recommendation is to remove unit 358 B from the Lodging inventory, allowing the installation to determine an alternate use for this unit. This unit will be removed from the Presidio of Monterey Wellness Solution and Lodging Master Plan.

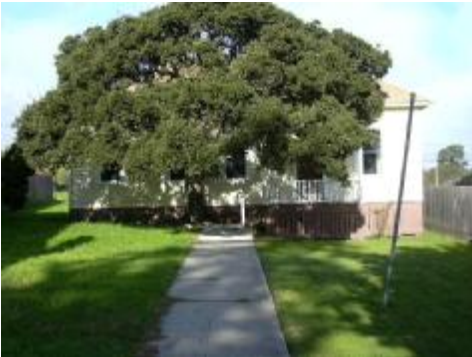
Building 359

Building 359, constructed in 1906, is a three bedroom historical structure located in the residential district of the installation. This facility is in poor condition, does not meet Lodging standards and cannot be reconfigured without significant reconstruction. To renovate building 359 to the new standards and configuration will exceed 50% of the replacement cost.

Our recommendation is to remove building 359 from the Lodging inventory, allowing the installation to determine an alternate use for this facility. This facility will be removed from the Presidio of Monterey Wellness Solution and Lodging Master Plan.

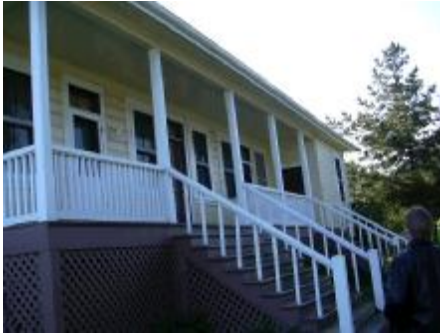
*Bldg 354A
Front Porch
Presidio of Monterey
Monterey, CA*

Because the Condition Assessment to Replacement Cost Ratio is greater than 50.00%, repair of Building 354 A is not recommended.

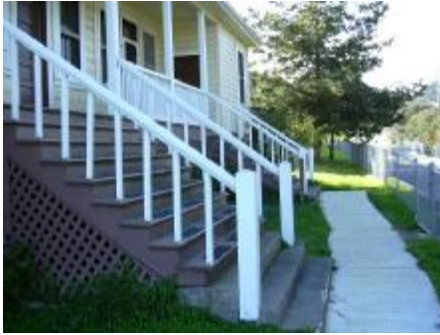
*Building 354B
Front Porch
Presidio of Monterey
Monterey, CA*

Because the Condition Assessment to Replacement Cost Ratio is greater than 50.00%, repair of Building 354 B is not recommended.

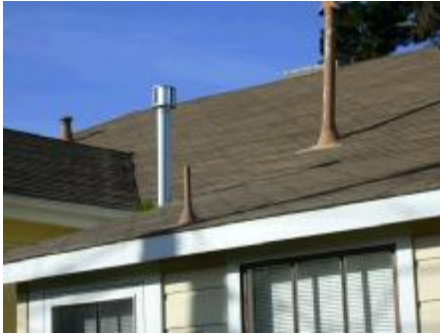
*Bldg 356A
Roof
Presidio of Monterey
Monterey, CA*

Because the Condition Assessment to Replacement Cost Ratio is greater than 50.00%, repair of Building 356 A is not recommended.

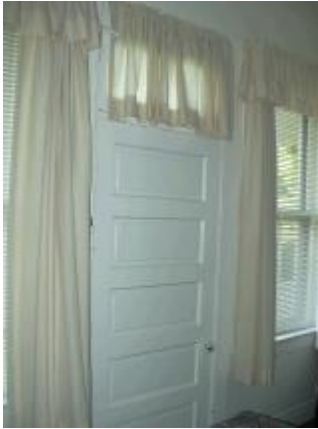
***Bldg 356A
Door and Window
Presidio of Monterey
Monterey, CA***

- Analysis: The original wood windows and frames are in poor condition.
- Recommendation: Replace the windows and frames.

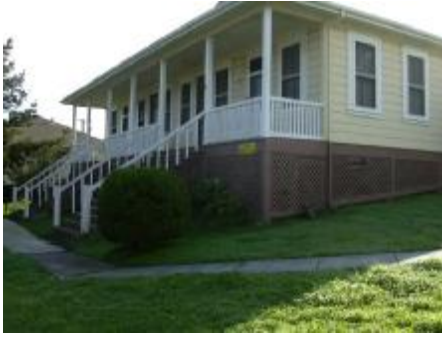
*Bldg 356B
Porch View
Presidio of Monterey
Monterey, CA*

Because the Condition Assessment to Replacement Cost Ratio is greater than 50.00%, repair of Building 356 B is not recommended.

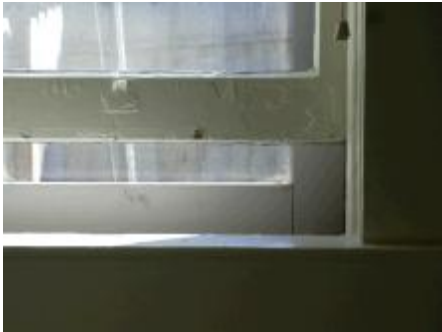
Bldg 356B
Window and Sill
Presidio of Monterey
Monterey, CA

- Analysis: The original wood windows and frames are in poor condition.
- Recommendation: Replace the windows and frames.

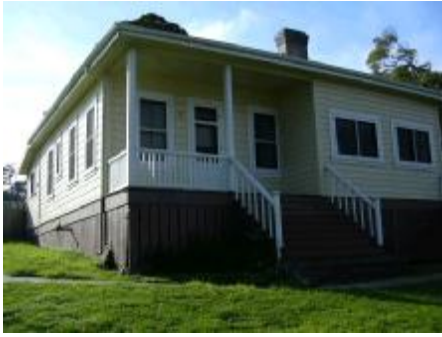
*Bldg 358A
Front View
Presidio of Monterey
Monterey, CA*

Because the Condition Assessment to Replacement Cost Ratio is greater than 50.00%, repair of Building 358 A is not recommended.

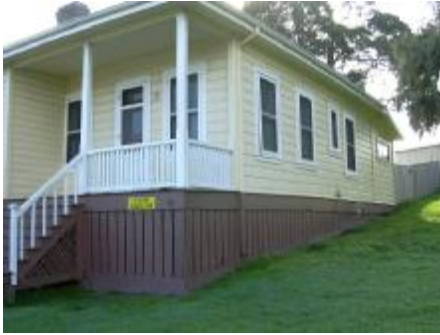
*Bldg 358B
Front View
Presidio of Monterey
Monterey, CA*

Because the Condition Assessment to Replacement Cost Ratio is greater than 50.00%, repair of Building 358 B is not recommended.
